Navajo Abandoned Uranium Mine

Site Screen Report

Ramco No. 20 AUM Site

Navajo AUM Western Region

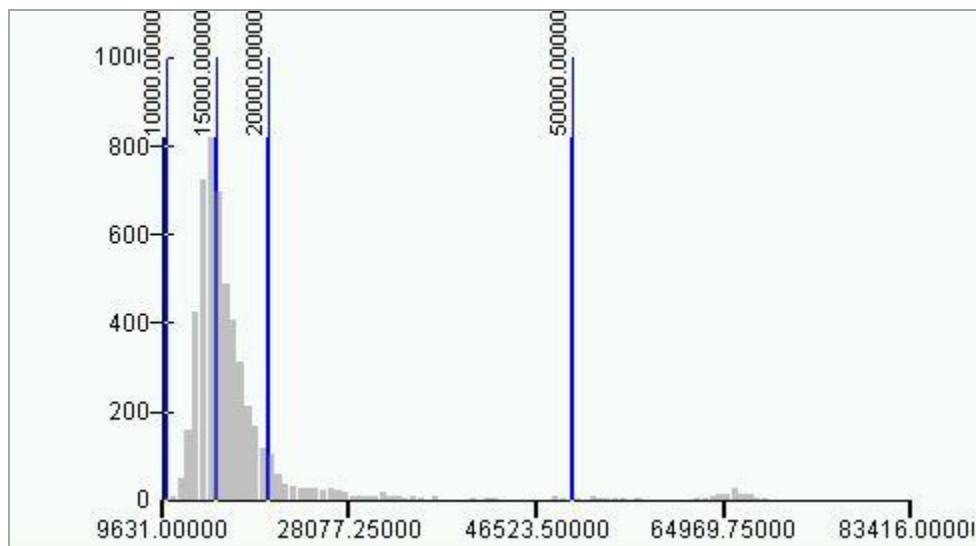
The following chart and statistics were generated by ESRI ArcGIS 9.3.1, and show the general distribution of the site gamma radiation measurements. The horizontal X axis represents the gamma radiation reading levels in cpm (lowest levels to the left). The vertical Y axis represents the frequency of each gamma radiation level.

Count:	5293
Minimum:	9631.00000
Maximum:	83416.00000
Sum:	93641289.00000
Mean:	17691.53391
Median:	15242.00000
Standard Deviation:	9102.70465

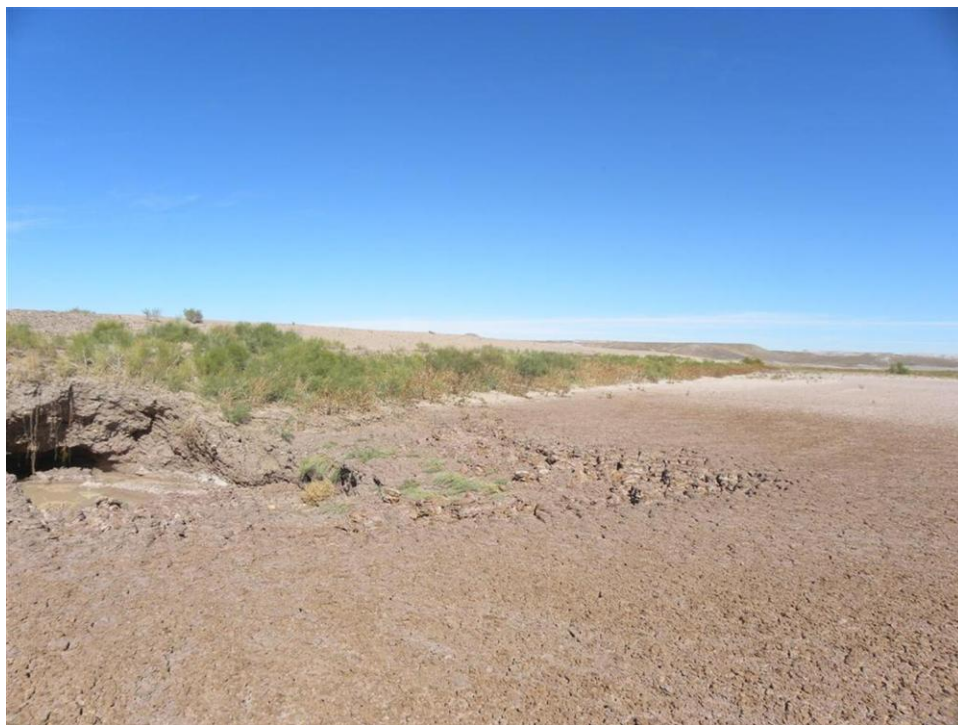
Former pond (from topo) and surrounding berm, breaced in the SW, some standing water in effluent area; erosion control berm area, shared with site 151

0 to 0.25 miles: Apparent pond area with drainage conduits, mostly dry, some standing water in breached/effluent area in the SW section.

Photo 4. Ramco No. 20 mine site, pond area, standing water in effluent channel

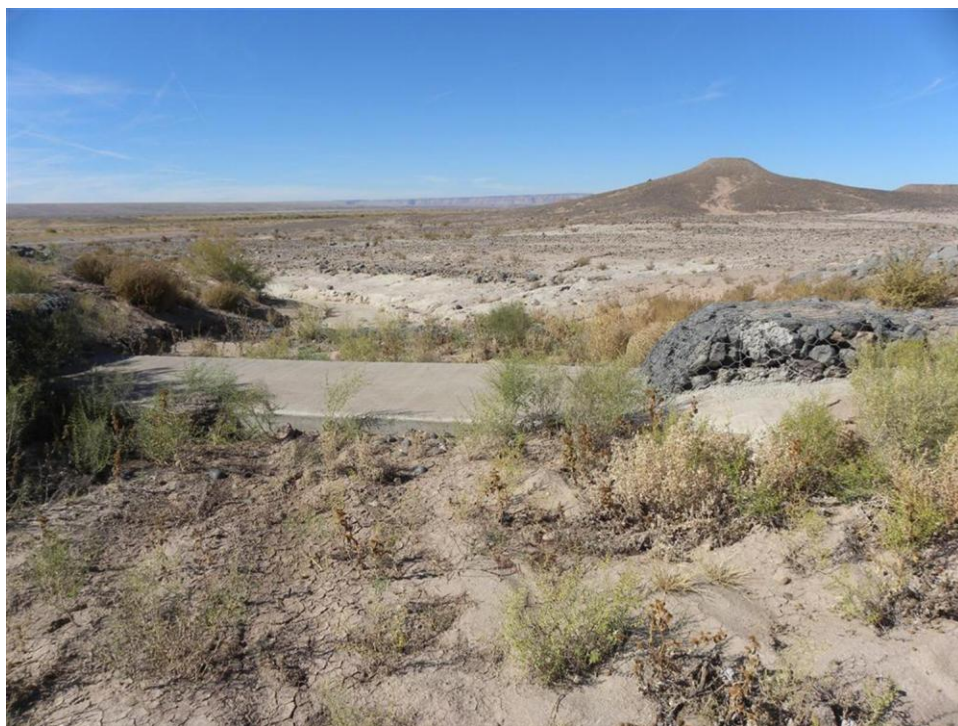
Photo 5. Ramco No. 20 mine site, pond area cement barrier/rip rap

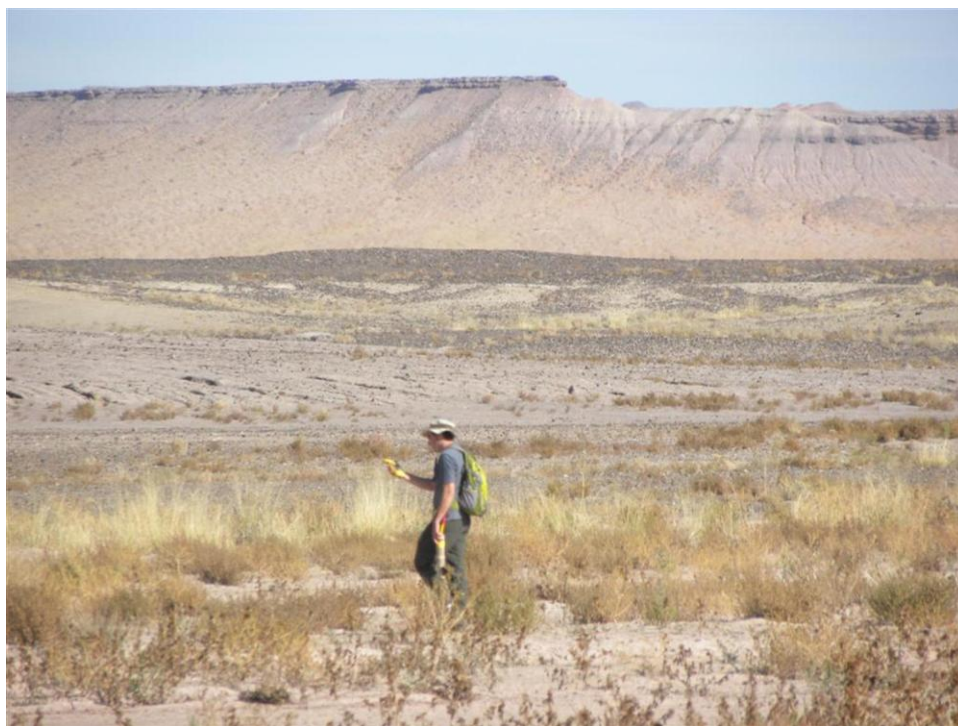
Photo 6. Ramco No. 20 mine site, gamma reading collection

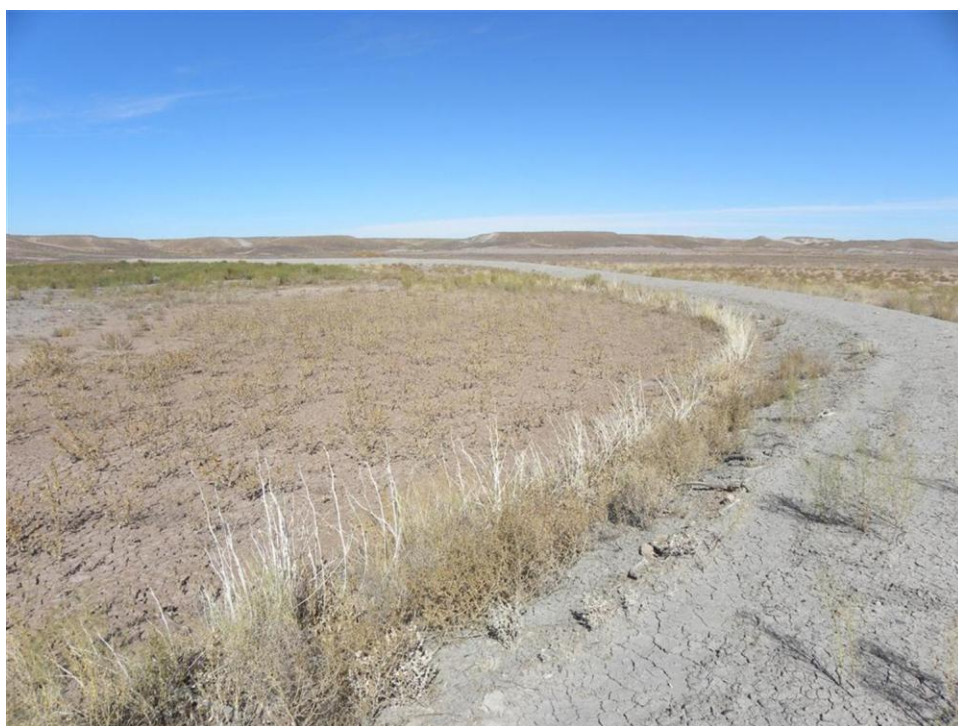
Photo 8. Ramco No. 20 mine site, berm shared with site #151

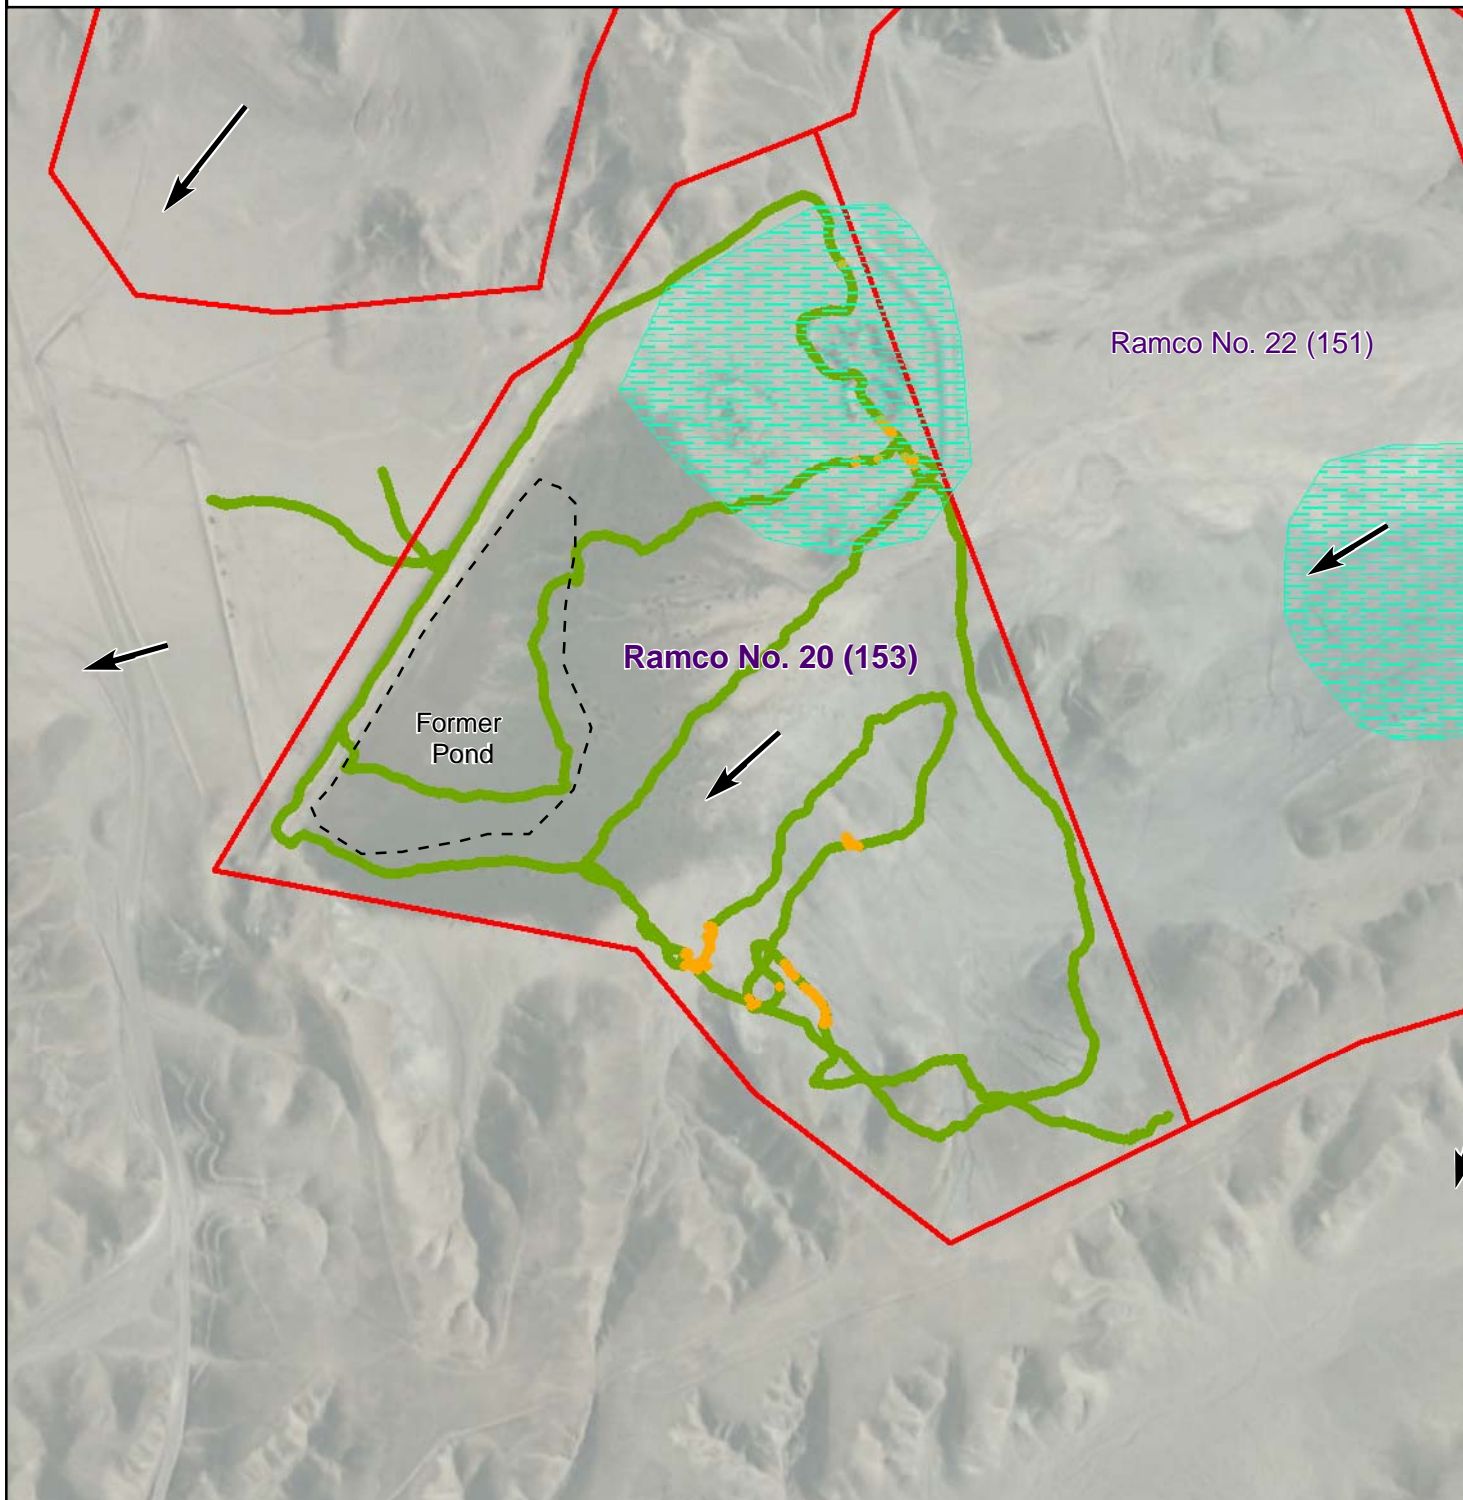
A total of 5,293 gamma radiation measurements were collected from the mine site, ranging from 9,631 cpm to 83,416 cpm. The measurements collected in the pond area were found mostly at background levels, with a few isolated hot spots with maximum levels of 85,000 cpm. The measurements are represented in Figures 1 and 2.

**Figure 1 - Gamma Radiation Measurements, Above Two Times Background
Ramco No. 20 (153)
Coalmine Mesa Chapter, Navajo Nation**

Gamma survey conducted 11/2010
Measured as counts per minute (cpm)

Average background 12,312 cpm

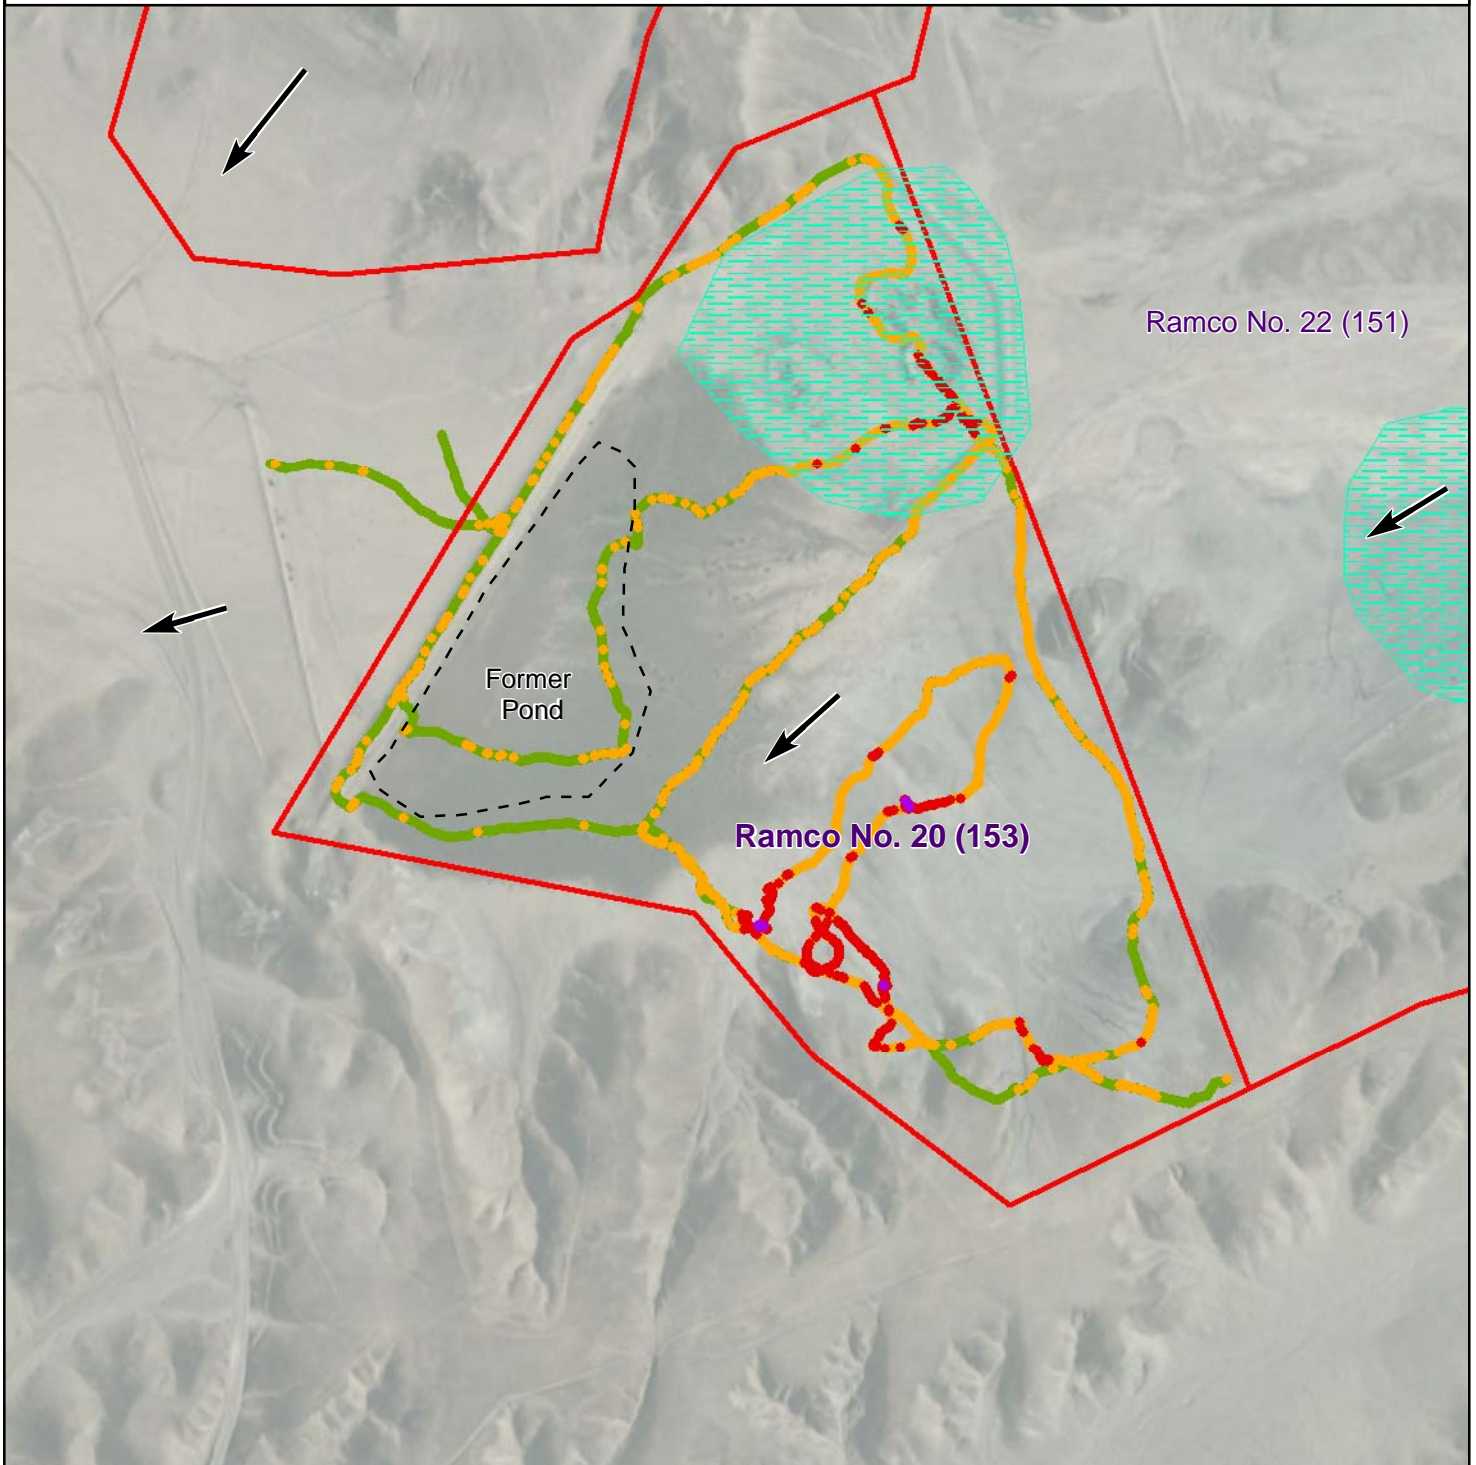
**Figure 2 - Gamma Radiation Measurements
Ramco No. 20 (153)
Coalmine Mesa Chapter, Navajo Nation**

**Gamma survey conducted 11/2010
Measured as counts per minute (cpm)**

Average background 12,312 cpm
